The Locomotive

OF
THE HARTFORD STEAM BOILER
INSPECTION AND INSURANCE CO.

INDEX
to
VOL. 42 - 43

HARTFORD, CONN.
1938-1939

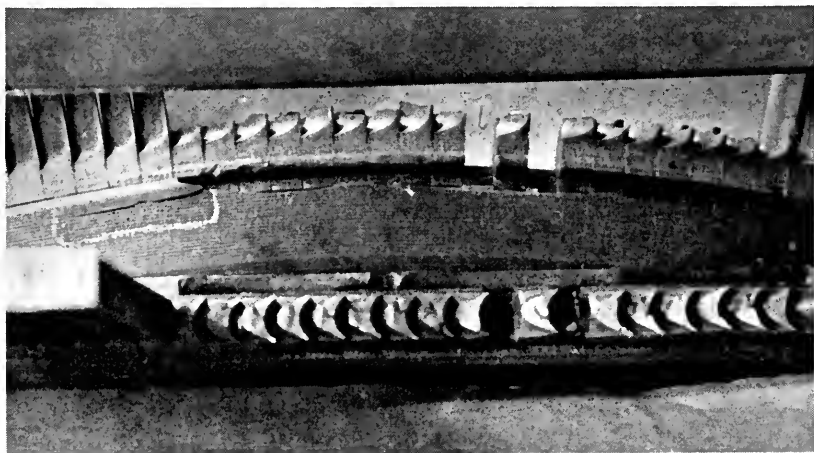
The original point of failure occurred at the rim of the wheel in the shoulder of the groove in which the blades were fastened. Figure 2, which was taken with the aid of a mirror, gives both a top and side view of the fracture. The appearance of the broken metal indicated that part of the crack had existed for some time. Just what caused the crack originally could not be determined but as a burr was found on the dove-tail of one of the broken blades, the thought was expressed that when this blade was installed the tight fit produced sufficient wedging action to start a small crack on the inside of the shoulder. Then, progressing gradually along the rim of the wheel and through the shoulder, the crack finally so weakened the disc that it broke from centrifugal force.

Figure 2—Taken with the aid of a mirror, this picture gives a close-up view of both the top and one side of the broken section in the turbine rotor shown in Figure 1.

This accident is a good illustration of the importance of careful observation of a turbine's vibration. When an appreciable increase is noted, the unit should be shut down immediately. In this case, through discovery of the damaged condenser tubes and the subsequent investigation, it is quite likely that a much more costly accident was avoided, for if the turbine had been operated for an appreciable time with the broken wheel, the continual vibration created by the unbalanced rotor might have caused further damage to the unit.

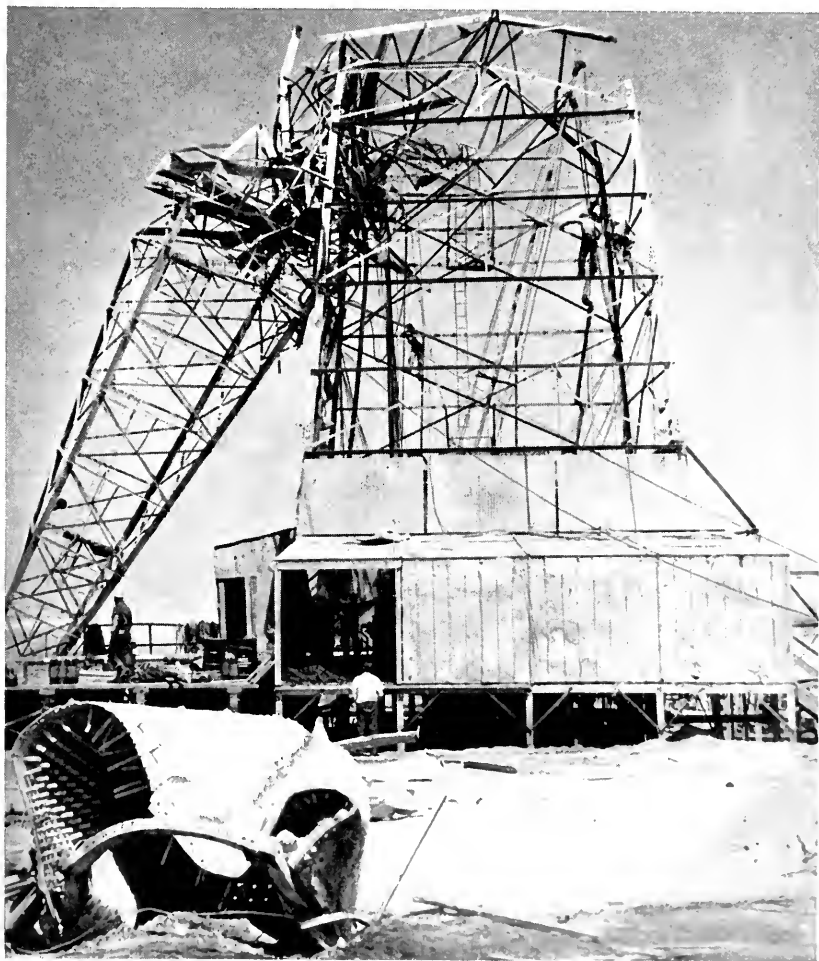
Figure 2—Derrick in an oil field wrecked by an explosion of an oil-well drilling boiler which was located a quarter of a mile away. The boiler's fire box that crashed into the derrick is shown in the foreground.

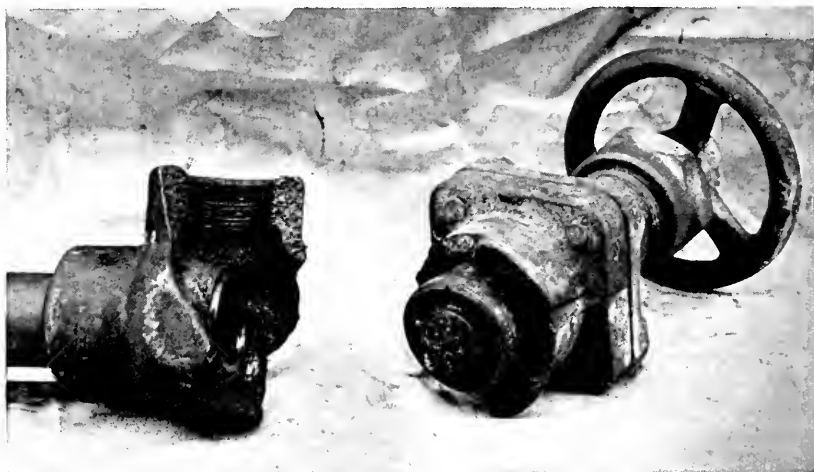
Figure 2—View of the broken by-pass valve which led to the violent explosion described on Page 203.

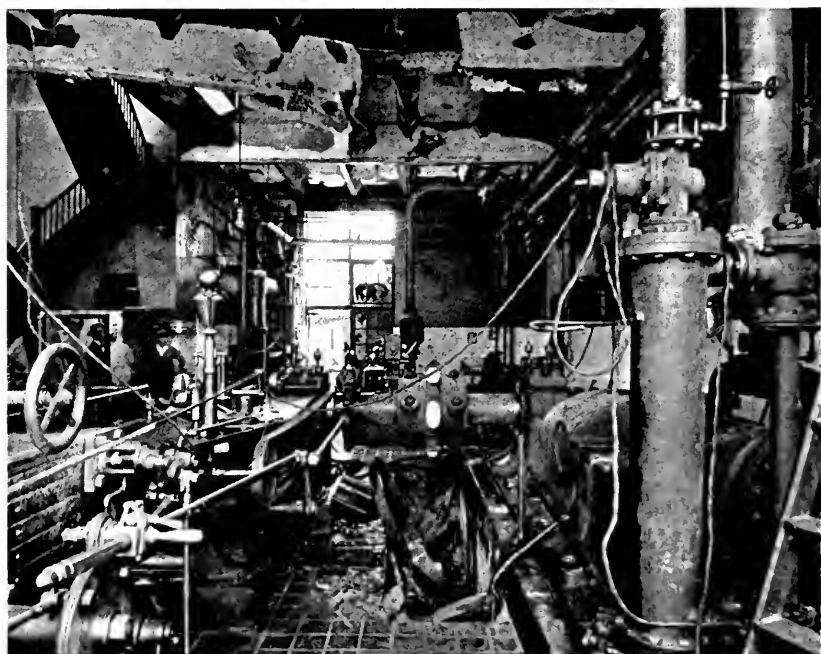
Figure 3—When a 12' flywheel on this steam-driven ammonia compressor ran away, the resultant property damage amounted to more than \$10,000.

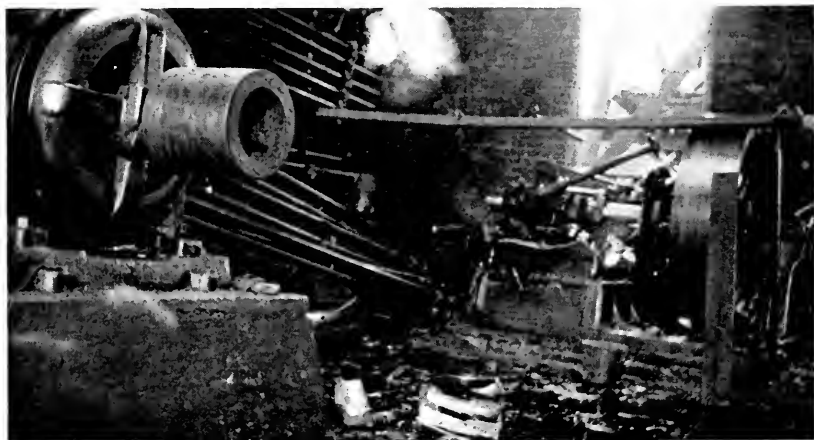
The following account of an explosion shows the danger in running a motor-driven compressor with the stop valve closed in the discharge line and also shows the value of an overpressure-actuated cut-out for the driving motor. According to the statement of the operator who barely escaped being killed, the explosion was accompanied by a blinding flash of fire. It was found that he had started the compressor with the discharge-line stop valve closed and had operated the machine in that manner for nearly four hours. As a result, the ammonia gas temperature increased greatly and the compressor overheated. What actually happened then isn't known but the conjecture is that a piston seized and caused a shock which broke the crankcase. The hot oil vapor or

Figure 4—Only the bottom of the crankcase, the shaft and the wheel remained after this vertical twin-cylinder belt-driven ammonia compressor exploded. The cause was attributed to a combustion explosion in the crankcase. \$7,500 was the estimated damage.

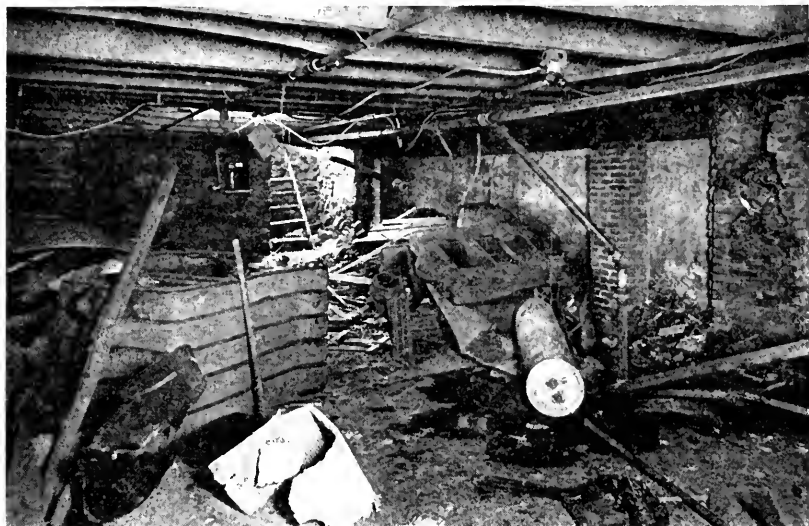
Figure 1 (Top)—An explosion of a cast iron sectional heating boiler caused this damage. A new boiler, it had been placed in service for the first time only a short while previously.

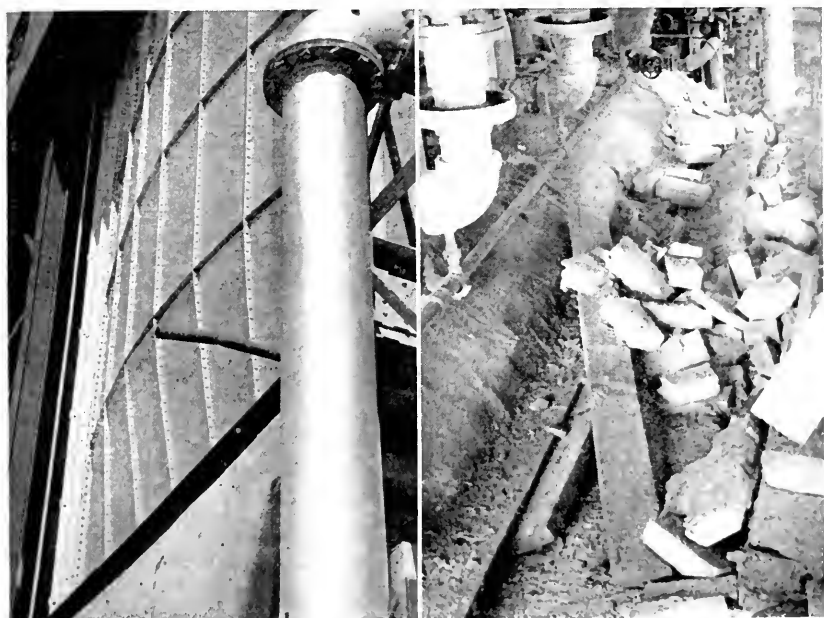
Figure 5—(Left) and 5A (Right)—Two pictures showing some of the damage caused by a furnace explosion to a large water-tube boiler in an Arizona utility power house. The one at the left shows one wall of the boiler's economizer bulged out several inches, while the other gives a view of damaged brickwork in the top of the setting.

manually controlled burners are usually traceable to operating errors, such as starting the fires with the stack dampers closed or with the drafts improperly adjusted. Furnace explosions have resulted from fuel leakage into the furnaces of idle boilers, the fuel gases later being ignited by hot brickwork or in some other way. Primarily poor maintenance is the usual reason for such losses.
